The Original Engine Cooling Pump Since 1921

18000 Pump Series Technical Guide

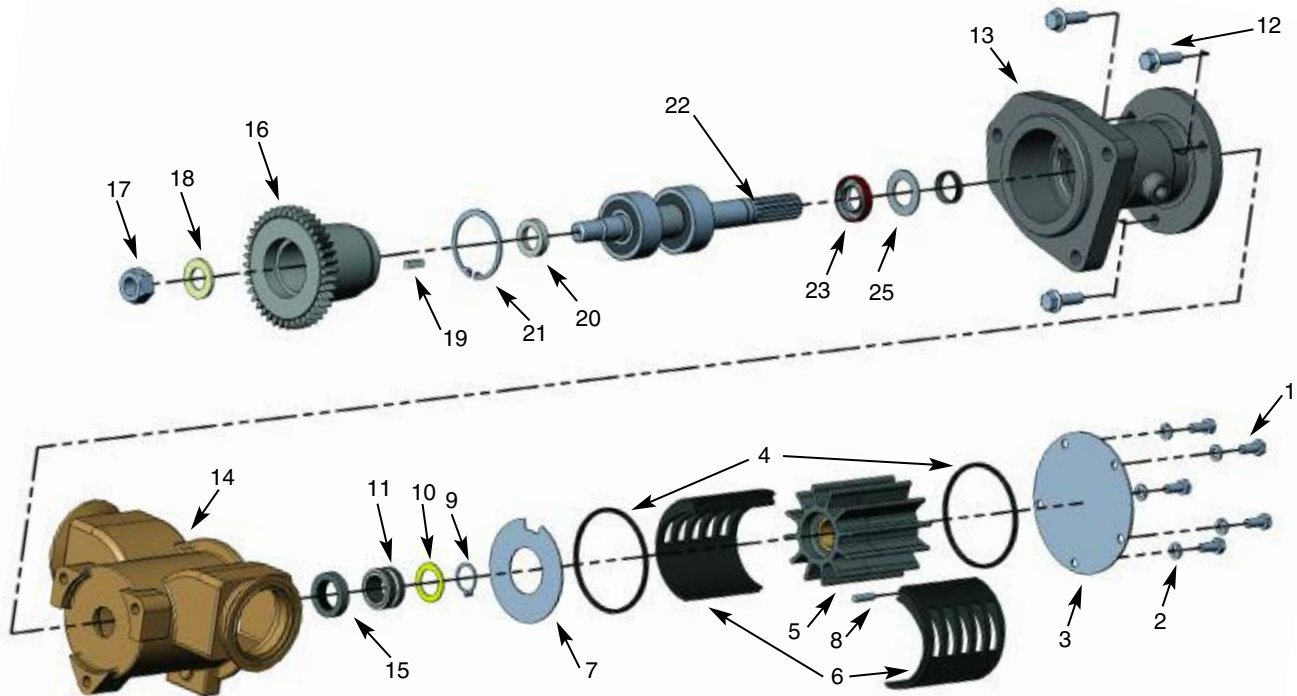
Assembly / Disassembly Instructions

The following assembly/disassembly procedures apply to all 18000 Series pumps. Deviations from pump to pump are primarily a result of different methods of drive and mounting. Pump numbers can be found stamped into the cover plate of the pump.

- A. Remove the bolts (1) and lockwashers (2) from the cover (3).
- B. Remove the cover, quad rings (4), impeller (5), cam liner halves (6), and wearplate (7). Note the direction of the impeller blades to ensure proper replacement of the impeller during the assembly procedure. Caution: the pin (8) might fall out from its place between the cam liner halves.

- C. Using external snap ring pliers, remove the retaining ring (9) from the shaft.
- D. Slide the washer (10) and mechanical seal (11) off of the shaft.

- E. Remove the bolts (12) holding the body (13) to the housing (14).
- F. Slide the housing off of the shaft and body assembly.
- G. Press the seal seat (15) out of the housing.

- H. When applicable remove the drive gear assembly: while supporting the drive gear (16), remove the nut (17), nut washer (18), and key (19) from the shaft. Slide the gear off of the shaft and remove the thrust washer (20) behind the gear.

- I. Using internal snap ring pliers, remove the retaining ring (21) from the body. Remove the bearing shield (24) from the body.
- J. Press the bearing and shaft assembly (22) out of the body.

- K. Remove the lip seal (23) and washer (25) from the body.
- L. Inspect the shaft for grooving of the lip seal area and heavy fretting of the spline portion that drives the impeller. Inspect the bearings for loss of grease, corrosion, and rough rotation. If the shaft or bearings exhibit such a wear, replace the entire shaft and bearing assembly (22) listed on page 3.

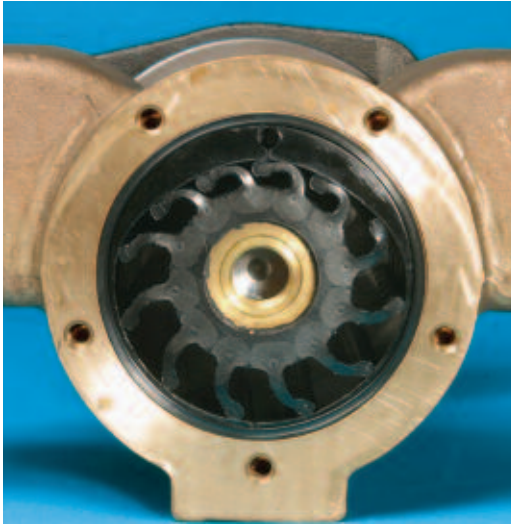
Models: G1808, G18081-01 and G1810

Vanes flipped to the left
(viewed from cover).

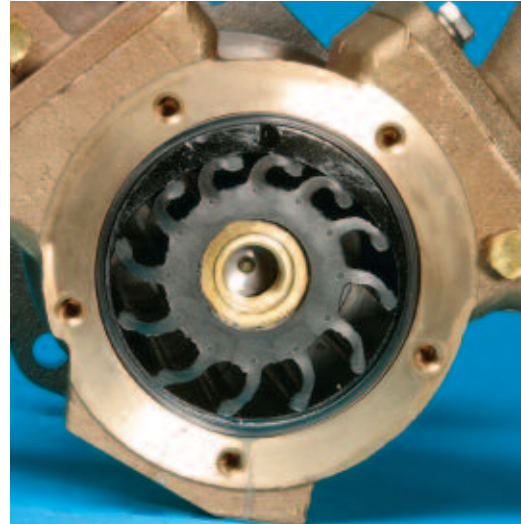
Models: G1801, G1804, G1805, G1806,
G18061-01, G1807, and G18071-01

Vanes flipped to the right
(viewed from cover).

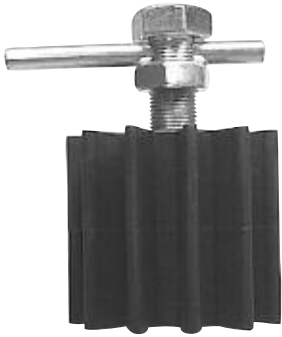
18000 Impeller & Impeller Puller

The patented 18000 impeller with threaded insert makes replacement easy when using the inexpensive Sherwood Impeller Puller (Model #23631).

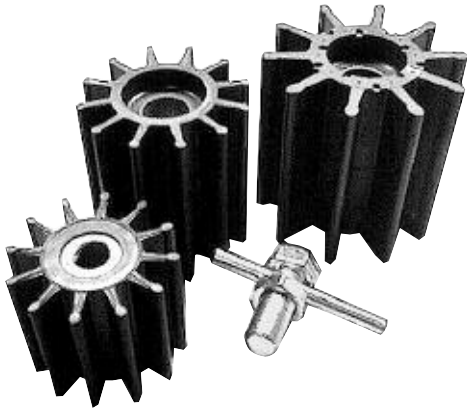
- Remove the cover.
- Insert the Sherwood puller into the threaded insert.
- Screw the puller against the shaft lifting the impeller until loose.
- Twist and pull the impeller out of the pump.

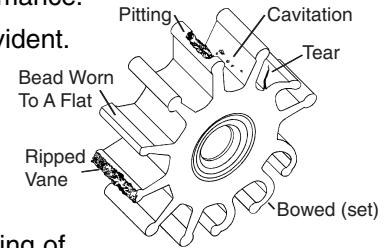
- Impeller Inspect for cracks or tears. Also, inspect for excessive abrasion of vane ends. Replace annually, or if any of the conditions exist, as in the picture below.*
